**MATERIALS SCIENCE DIVISION
COAL TECHNOLOGY
FOURTH QUARTERLY REPORT,
JULY—SEPTEMBER 1975**

ARGONNE NATIONAL LABORATORY, ARGONNE, ILLINOIS

ANL-76-7

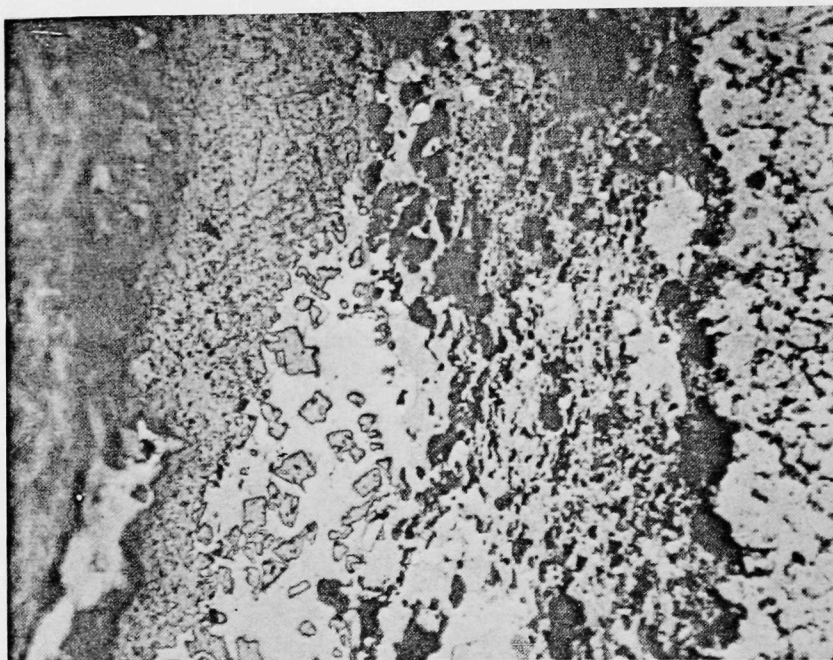
Fig. 24. Coating Shown in Fig. 22 after 500-h Exposure in Coal-gas Mixture. (Note: Coating completely consumed and substrate was corroded badly.) Mag. 200X.

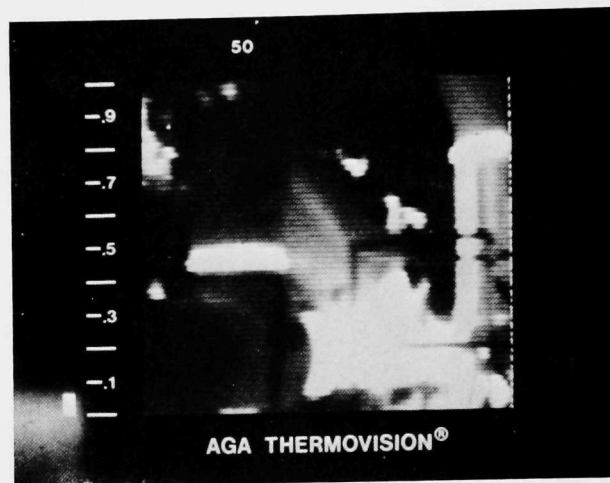
Fig. 5a. Photograph of the infrared thermal Scan of the CO₂ Acceptor Coal Crusher.
